**KING HIGHWAY LANDFILL
POST-REMEDIATION INSPECTION FORM**
**SOP M - Post-Remediation Inspection
Procedures**

Inspection Date: 6/8/2012 Weather Conditions: Sunny, 70's, light wind Inspector(s): M. Kohagen
 Time Arrived: 8:00 (AM) Time Departed: 12:00 (AM)

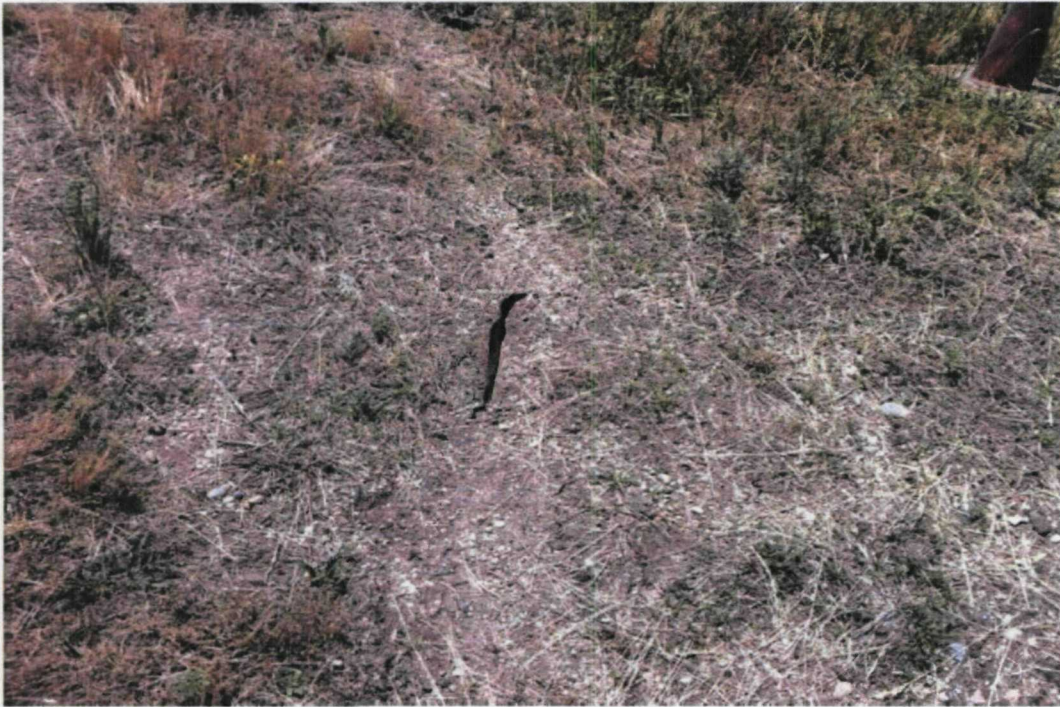
Inspection Items	Condition Satisfactory		Response	Comments/Proposed Action Items	Photo No.
	Yes	No			
Cover System					
Settlement		X	Strip the soil, place and compact suitable soils within the depression, and replace excavated soil. Once the proper slope is restored, reseed the disturbed area	Suspected settlement in the stressed vegetation area on the north side of the landfill, south of the diversion berm. A plan is being prepared to address possible liner failure, and will be submitted to MDEQ for review and approval by June 30, 2012.	2
Water Ponding	X				
Soil Erosion	X		Regrade or place additional appropriate materials in affected areas and promptly reseed to establish vegetative growth	Unknown geotextile exposed in the southwest corner of the landfill, adjacent to the sedimentation basin. The location will be inspected to determine whether the geotextile material is a remnant from erosion and sediment control implementation during installation of the final cover system. Additional topsoil will be placed over the geotextile, and the area will be seeded to establish vegetative growth.	1

Photo No. 1: Exposed geotextile located at the southwest corner of the landfill, adjacent to the sedimentation basin.

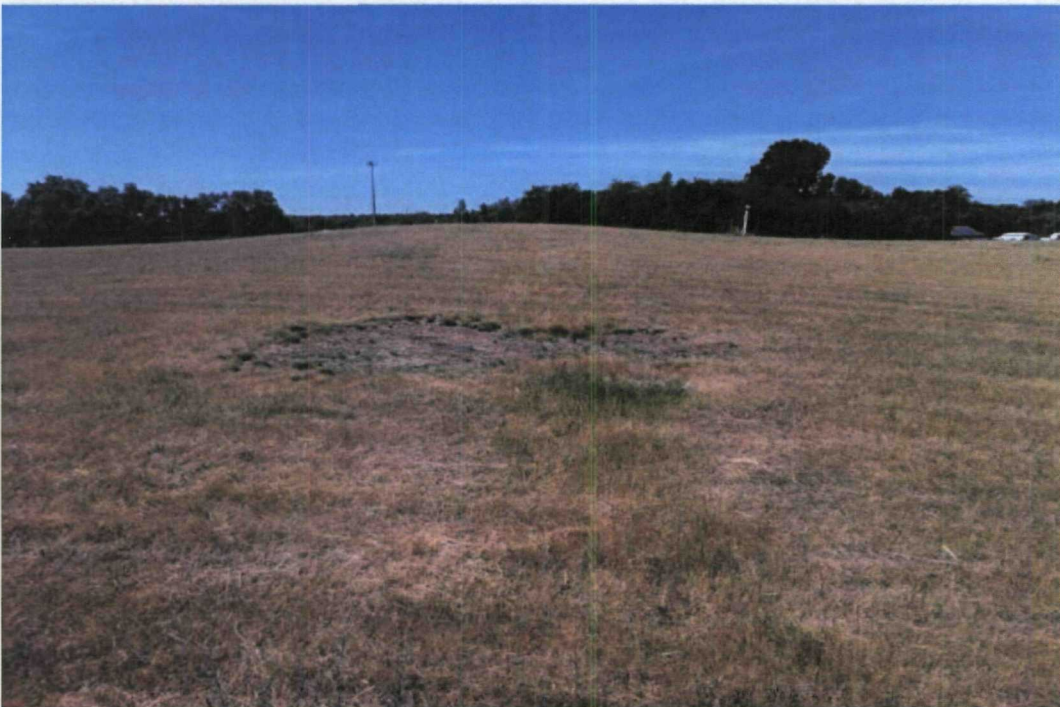
Slope Movement/Failure	X				
Exposed FML	X				
Undesirable Growth (Rooty Trees or Shrubs)	X				
Protruding Objects	X				
Burrowing Animals		X	Regrade or place additional appropriate materials in the affected areas and promptly reseed to establish vegetative growth	Several burrowing animal holes were observed at the landfill. None of the holes were observed in the final cover system. The holes will be filled and the areas seeded to establish vegetative growth. These areas will be monitored for additional holes generated by the burrowing animals.	3
Cracks	X				
Disturbance or Loss of Vegetation		X	Reseed areas of lost vegetation. Do not allow vegetation (except for grasses) to establish on the cover	An approximate 20' by 20' area of stressed vegetation was observed on the north side of the landfill, south of the diversion berm. Previous soil gas sampling detected elevated methane concentrations within this area. A plan is being prepared to address possible liner failure, and will be submitted to MDEQ for review and approval by June 30, 2012.	2

Photo No. 2: Area of stressed vegetation and possible settlement on the north side of the landfill, south of the diversion berm.

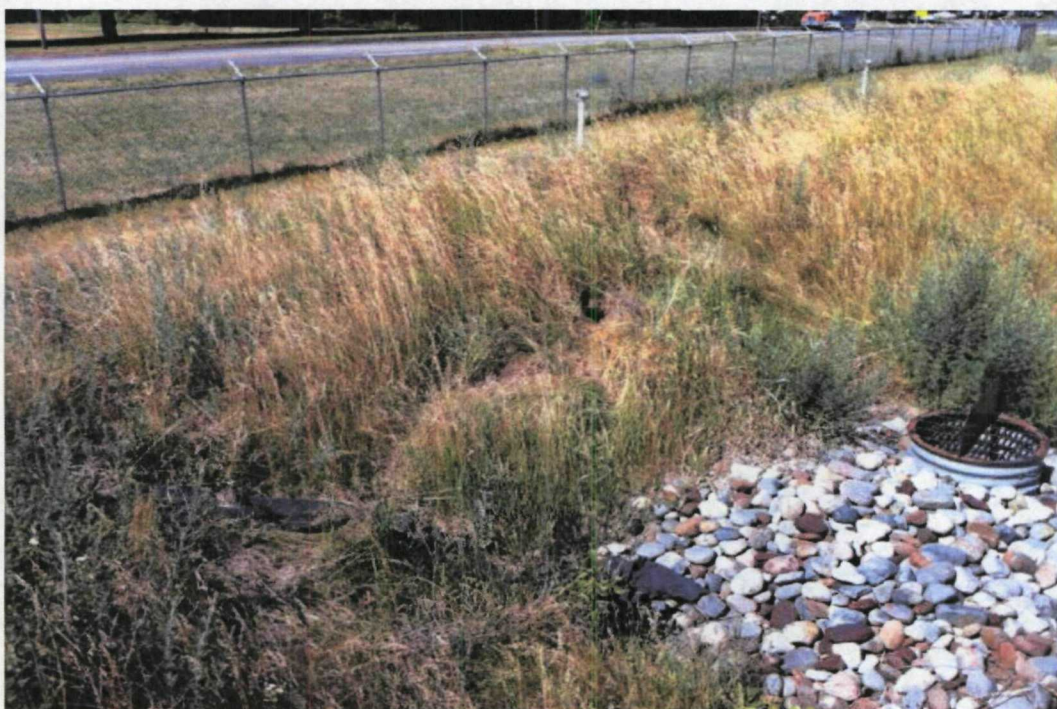
Photo No. 3: Location of observed animal hole adjacent to sedimentation basin outlet structure.

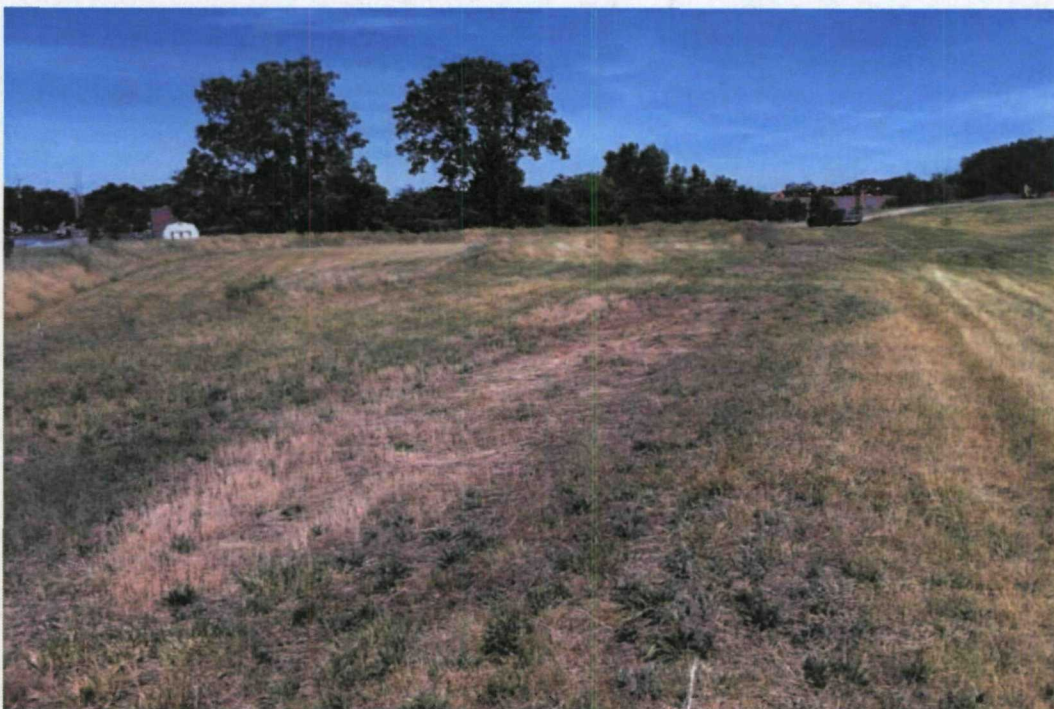
Inspection Items	Condition Satisfactory		Response	Comments/Proposed Action Items	Photo No.
	Yes	No			
Condition of Discharge Structures & Inlets	X				
Inappropriate Vegetation	X				
Ditches and Diversion Berms					
Siltation		X	Remove excessive sediment buildup	No standing water was observed during the inspection in the low area in the ditch immediately south of the gravel access road on the north side of the landfill; however, ponding water was previously observed. The ditch will be regraded during the work activities to address the stressed vegetation areas on the final cover system.	
Debris Buildup	X				
Disturbed Vegetation		X	Reseed areas of lost vegetation	An area of stressed vegetation was observed east of the sedimentation basin, outside the extent of the final cover system. Previous soil gas sampling within this area detected elevated methane concentrations. However, elevated methane concentrations were not detected during monitoring of the gas vents and probes located to the south and west of this area. Additional topsoil will be placed and the area reseeded in the fall to establish vegetative growth.	4

Photo No. 4: Area of stressed vegetation located outside the final cover system, east of the sedimentation basin.

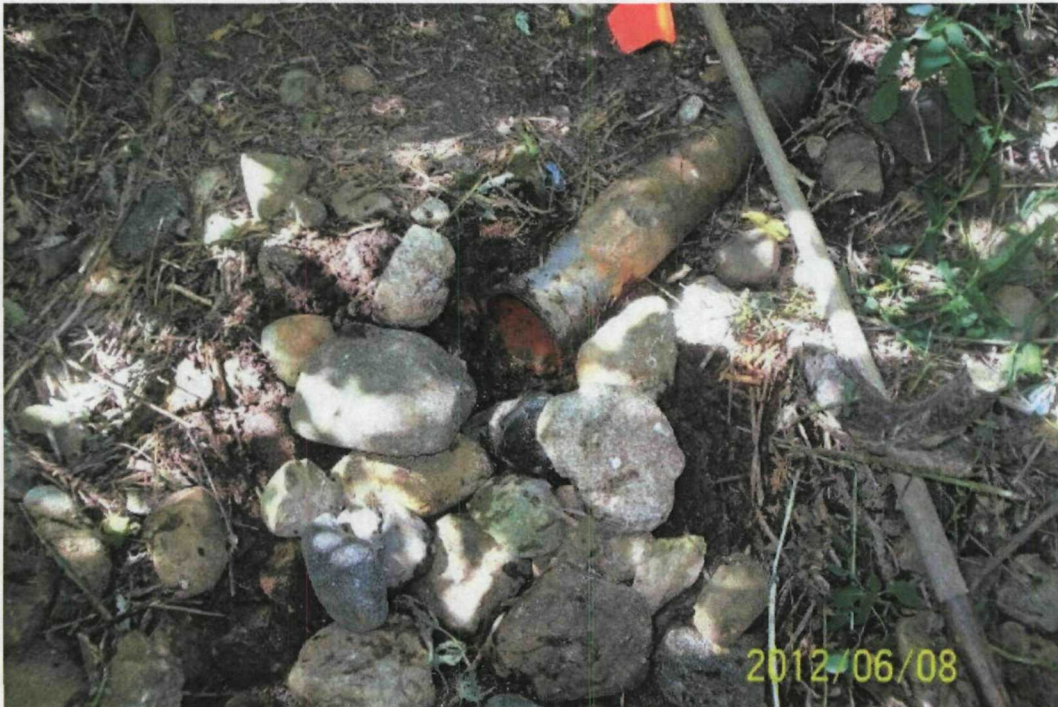
Erosion	X				
Culverts					
Siltation	X				
Clogging	X				
Riprap, Sheet pile Wall, and Erosion Control Blankets					
Instability or Damage	X				
Sheet pile Wall					
Soil Erosion, Subsidence, or Cracking Behind Wall	X				
Wall Joints	X				
Overall Wall Stability	X				
Surface Water and Pore Water Collection System					
Clogging of Outlets		X	Remove any debris or obstructions/blockages obstructing flow through the pipe	The north pore water outlet pipe was observed to be blocked by a root structure. The root structure was removed from the end of the pipe and riprap replaced around the outlet pipe to reduce the potential for future clogging. The southern pore water outlet pipe was not located. As-built survey data of the southern pore water outlet pipe is available, and the pipe will be located with Terra Contracting when survey equipment is available. If the south pore water outlet pipe is found to be blocked, the blockage will be removed.	5

Inspection Items	Condition Satisfactory		Response	Comments/Proposed Action Items	Photo No.
	Yes	No			
Evidence of Settlement/ Exposed Materials	X				
Condition of Inlet/Outlets		X	Replace or repair pipes that have been damaged such that flow is obstructed	At the time of inspection, the north pore water outlet was plugged by a large root structure. The root structure was removed and the initial purge of water from the outlet was tinted red. The water turned clear within approximately 5 minutes of removing the obstruction. The discharge from the north pore water outlet is now free flowing. The condition of the south pore water outlet pipe will be evaluated when the pipe is located.	5
Landfill Gas Management System					
Condition of Exterior Vent Pipe Components	X				
Condition of Exterior Gas Probe Components	X				
Evidence of Differential Settlement ¹	X				
Operation of Wind Turbine Ventilators	X

Photo No. 5: North pore water discharge pipe outlet.
